DAMAGE TO TREES AND REGENERATION LAYER RESULTING FROM TIMBER HARVESTING WITH THE USE OF EQUIPMENT AGGREGATED WITH FARM TRACTORS IN THINNED PINE STANDS*

Arkadiusz Stańczykiewicz, Janusz M. Sowa, Dariusz Kulak,
Krzysztof Leszczyński, Grzegorz Szewczyk

University of Agriculture in Krakow

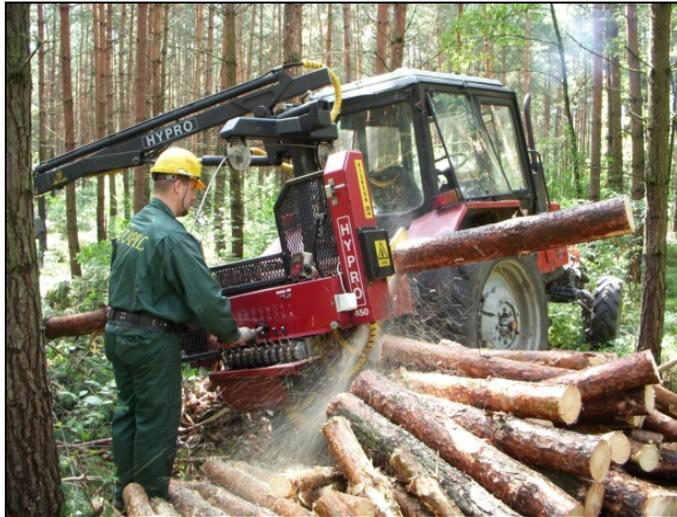
Fig. 1. HYPRO 450 Processor (photo A. Stańczykiewicz)
Rys. 1. Procesor HYPRO 450 (fot. A. Stańczykiewicz)

Field research was carried out in the Rybnik Forest District located within the Regional Directorate of State Forests in Katowice and in the Dąbrowa Tarnowska Forest District situated within the Regional Directorate of State Forests in Kraków. Timber harvesting by means of HYPRO 450 continuous debranching processor was carried out in the stands of Rybnik Forest District while harvesting by means of NIAB 5-15 cyclical debranching processor as well as a FRANSGÅRD V-6000 GS cable winch was realized in the Dąbrowa Tarnowska Forest District. Both processors were equipped in radio-controlled cable winches of 20 and 25 kN draw-bar pull. Detailed technical data of the processors (Fig. 1, 2) aggregated with BELARUS (MTZ) farm tractors were presented in the previous article [Stańczykiewicz 2011 a]. The FRANSGÅRD V-6000 GS manually operated cable winch of 60 kN draw-bar pull and 80 m long cable (Fig. 3) was aggregated with a PRONAR farm tractor.

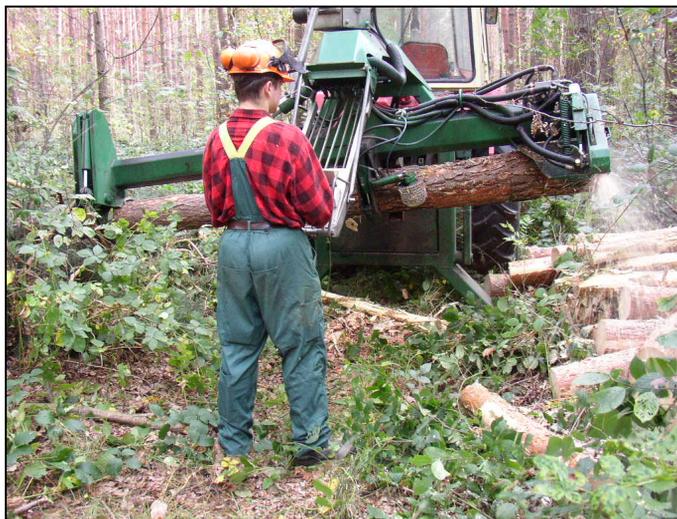
Fig. 2. NIAB 5-15 Processor (photo A. Stańczykiewicz)
Rys. 2. Procesor NIAB 5-15 (fot. A. Stańczykiewicz)

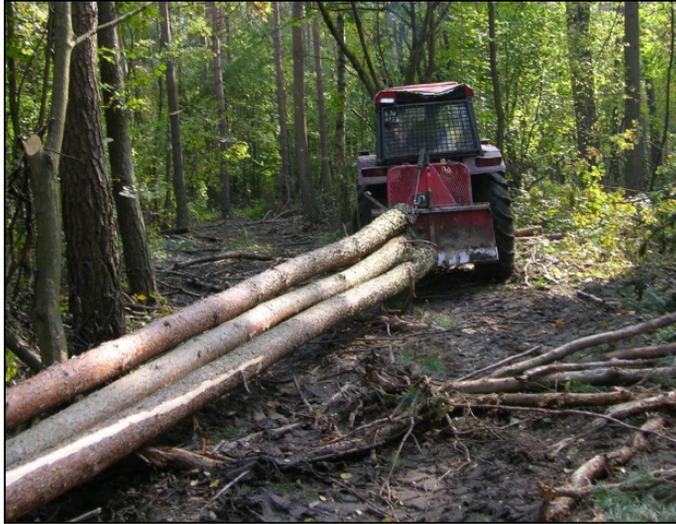
Fig. 3. FRANSGÅRD V-6000 GS cable winch (photo G. Szewczyk)
 Rys. 3. Wciągarka FRANSGÅRD V-6000 GS (fot. G. Szewczyk)
